FINAL PALAUEA CULTURAL RESERVE

Palauea, Kīhei, Maui, Hawai'i
Tax Map Key: (2) 2-1-023:034

DRAINAGE INSPECTION REPORT

October 30, 2017

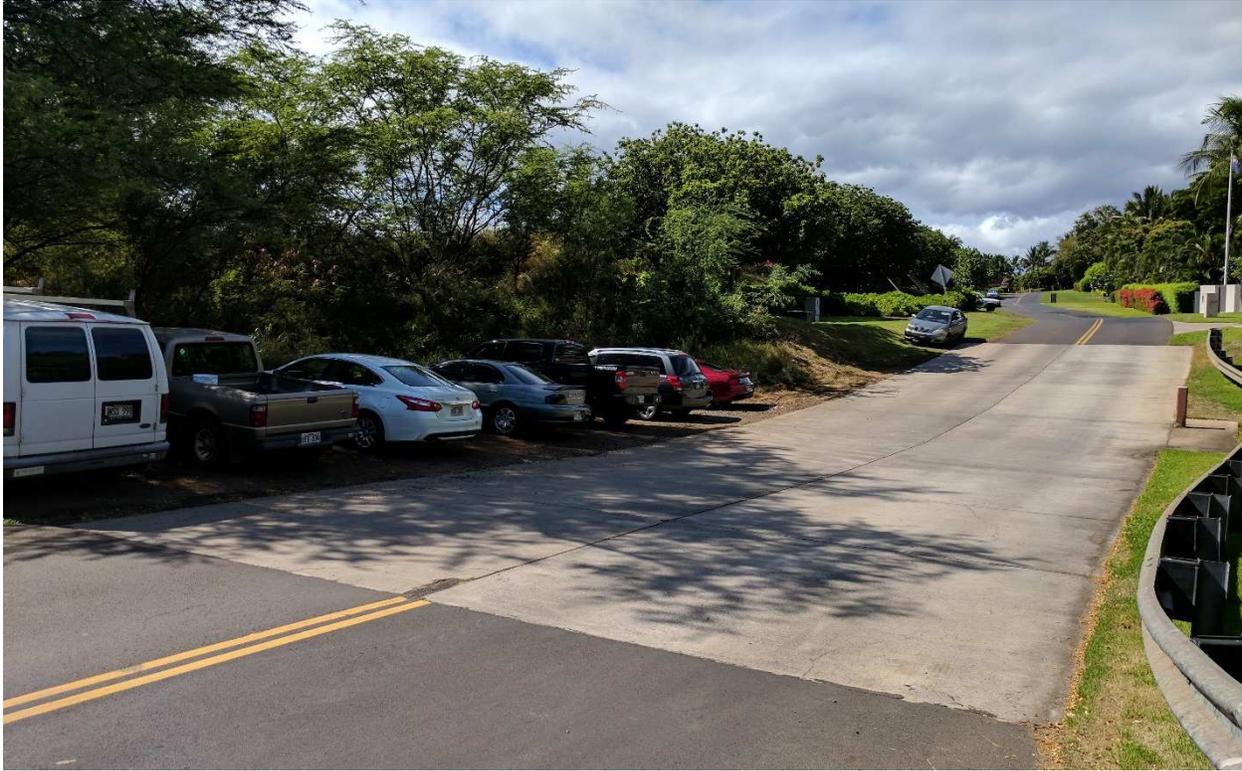
Photo 1: Concrete ford along Makena Road, facing south.

The drainage channel continues from OHA’s property into the Palauea Subdivision. The project area and boundary of the property ends approximately 100’ upstream from the grouted rip rap lined channel (see Photo 3). The inlet and outlet surrounding the four 90-inch culverts are lined with grouted rip rap. The bottom of the channel opens up to 88-feet wide downstream of the four culverts and is overgrown with vegetation to the concrete ford, as shown in Photo 7. The concrete ford at the Makena Road crossing does not appear to have any physical issues. However, parked vehicles were observed where the channel meets the concrete ford (see Photo 2). There should not be vehicles parked in the area before or during a storm event. In addition, a sign is posted on both ends of the concrete ford, “Do not cross when water level touches red on posts.” Any objects within the concrete ford may get washed downstream and impact the downstream properties.

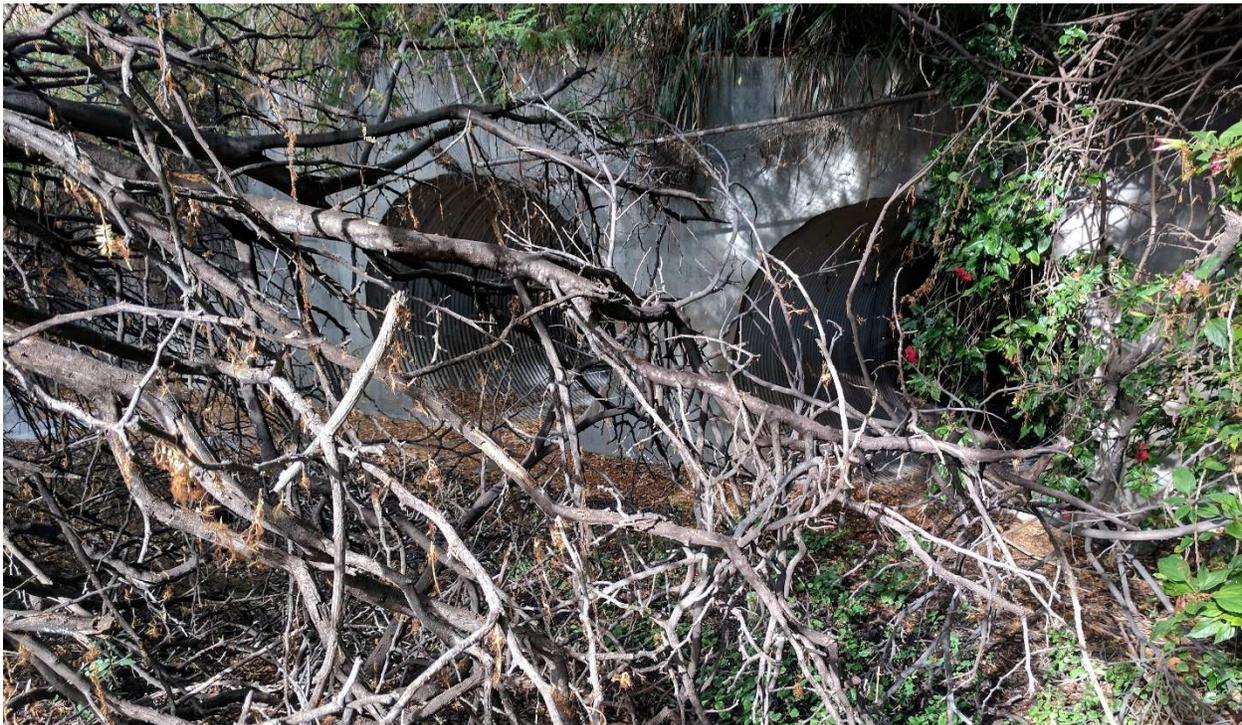
At the time of the inspection, the two 120-inch culverts appeared to have minimal debris at the upstream mouth of the culverts. However, a fallen tree from the adjacent golf course was observed at the top of the concrete apron. This may act as a blockage during large storm events and may impede runoff upstream of the culverts, contributing to localized flooding. Photo 2 depicts the current upstream condition of the project area. The fallen tree, as shown in Photo 2, should be removed by the golf course owner to prevent future drainage issues and possible liability issues.

Photo 2: Looking downstream at the two 120-inch culverts with fallen tree in the foreground.

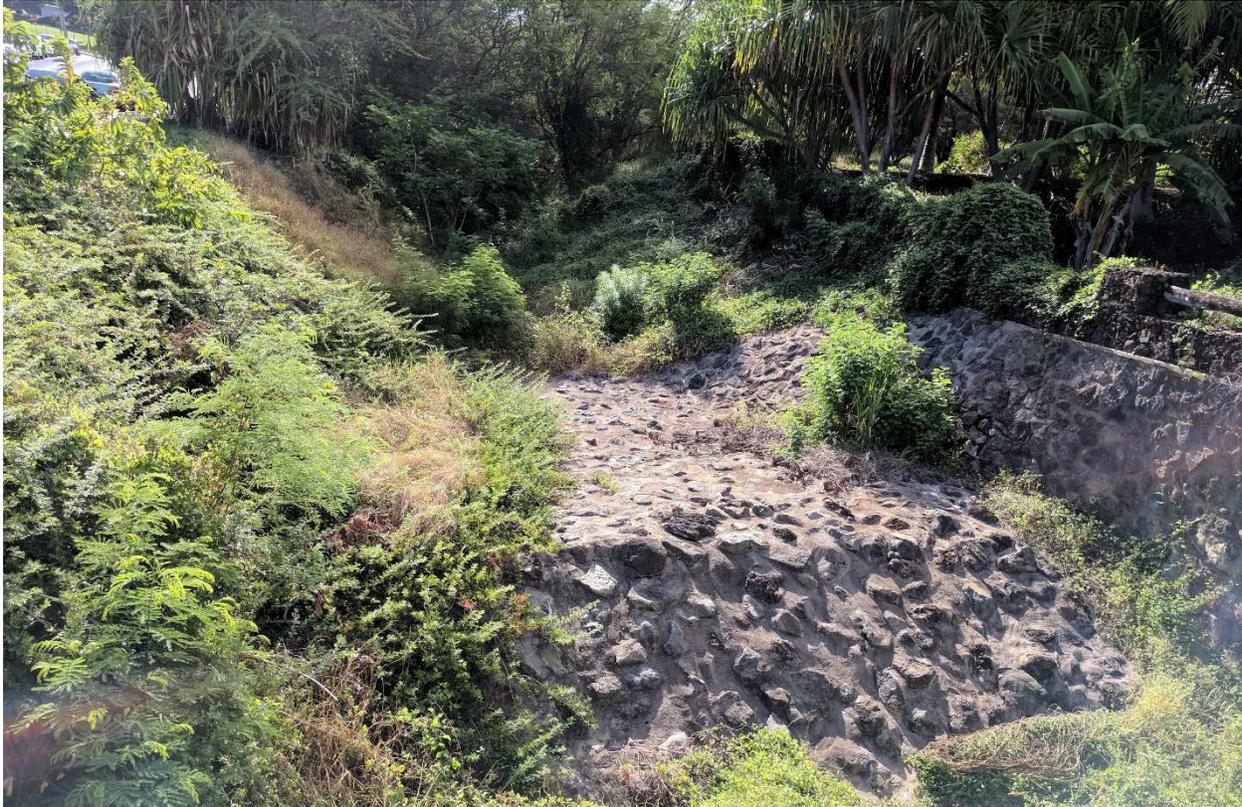
The majority of the project area is overgrown with brush, weeds, kiawe trees, and other various trees that cover the slopes and bottom of the existing drainage channel. Portions of the drainageway were inaccessible due to heavy brush and overgrowth, as shown in Photo 3. Specifically, the 24-inch and two 18-inch drain outlets between Makena Alanui Road and Makena Road could not be accessed due to the heavy brush and vegetation.

The channel width (33-feet) appears to be consistent with the FIS at the upstream section A-A. However, the channel appeared to narrow to approximately 10-feet towards the middle and bottom of the project area. The narrower channel bottom in these areas may constrict flow conveyance and yield higher water levels during storm events.

Photo 3: Looking upstream from Ualei Place towards the bottom of the Project Area

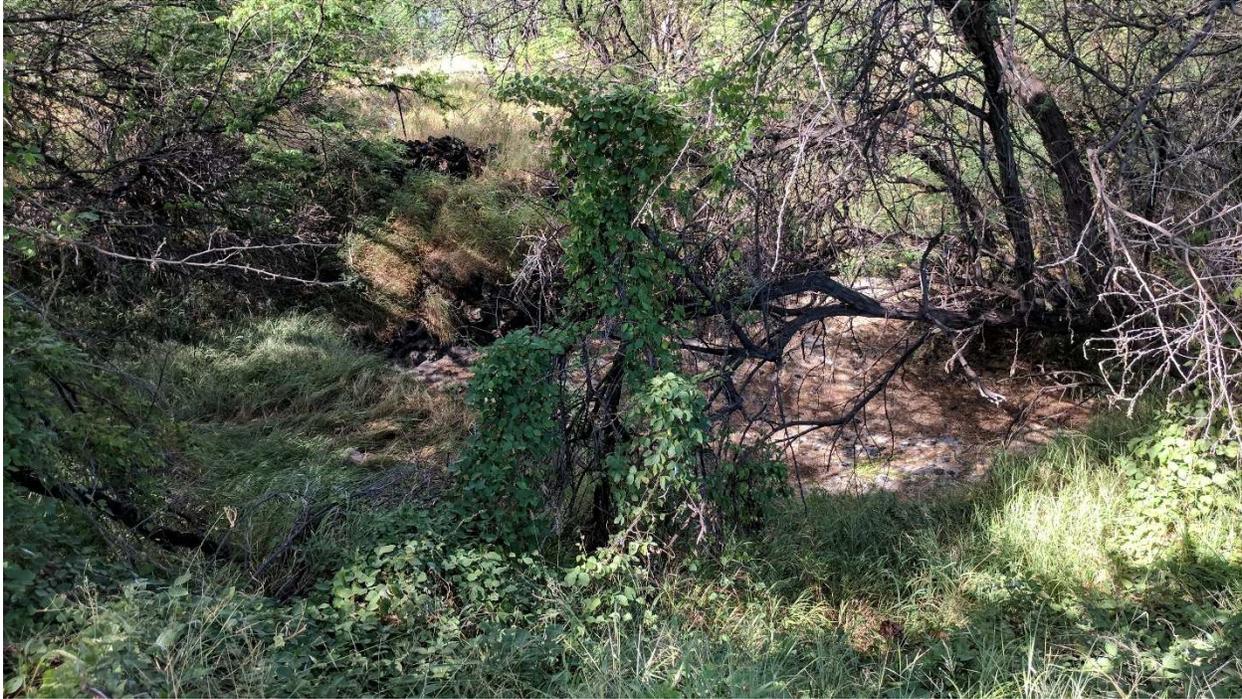
During the inspection, there were no areas of concentrated erosion or sedimentation observed along the channel, but erosion and sedimentation was observed sporadically throughout the project area. There were two areas of erosion observed during the inspection. Loose rocks were observed near the top of the project area along the Palauea Subdivision property (near Lot 3). The rocks appear to have broken off from the side of the channel and may be an area of concern for future erosion. Photos 4 and 5 highlight the areas of erosion. Additionally, an area near the bottom of the project area showed early signs of erosion, Photo 6. Figure 4 is a photo map to identify the photo direction and area of interest.

Photo 4: Looking towards the Palauea Subdivision for potential future slope erosion

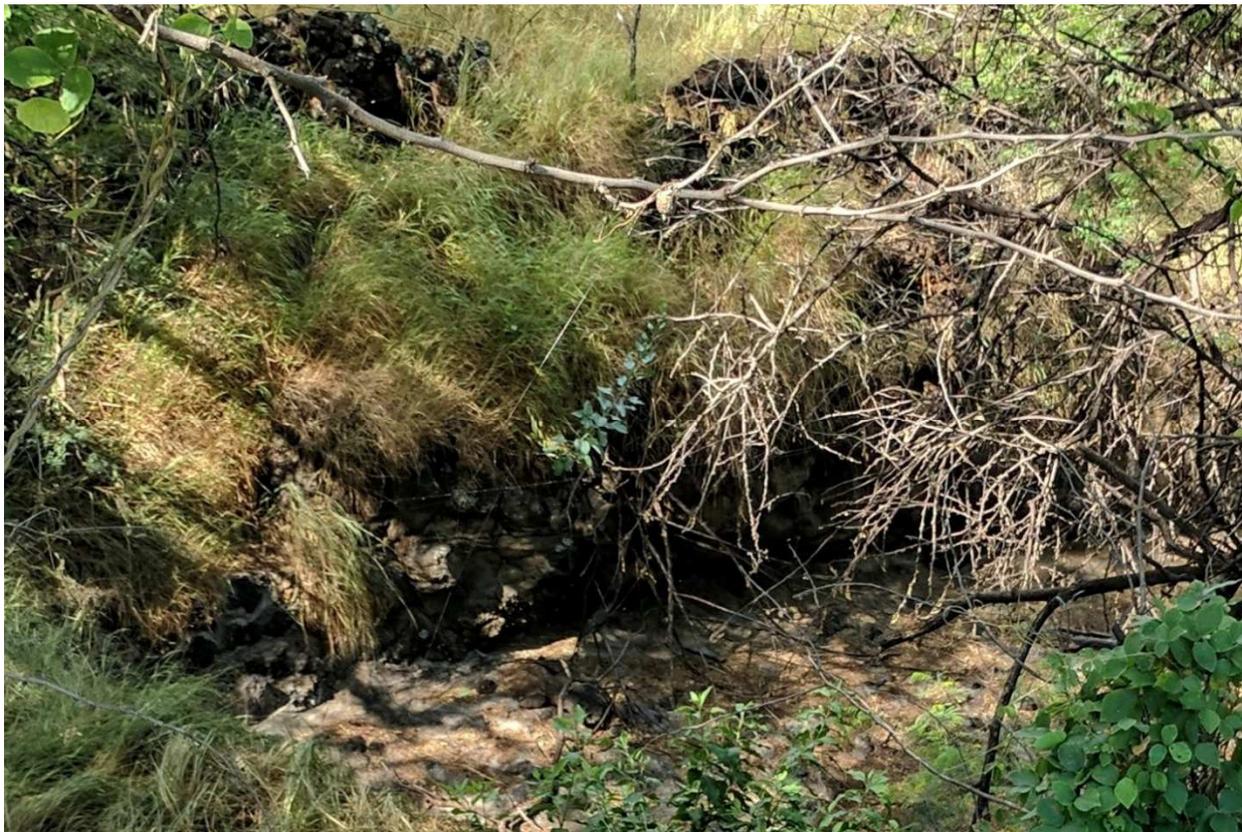
Photo 5: A close-up image of the area of interest

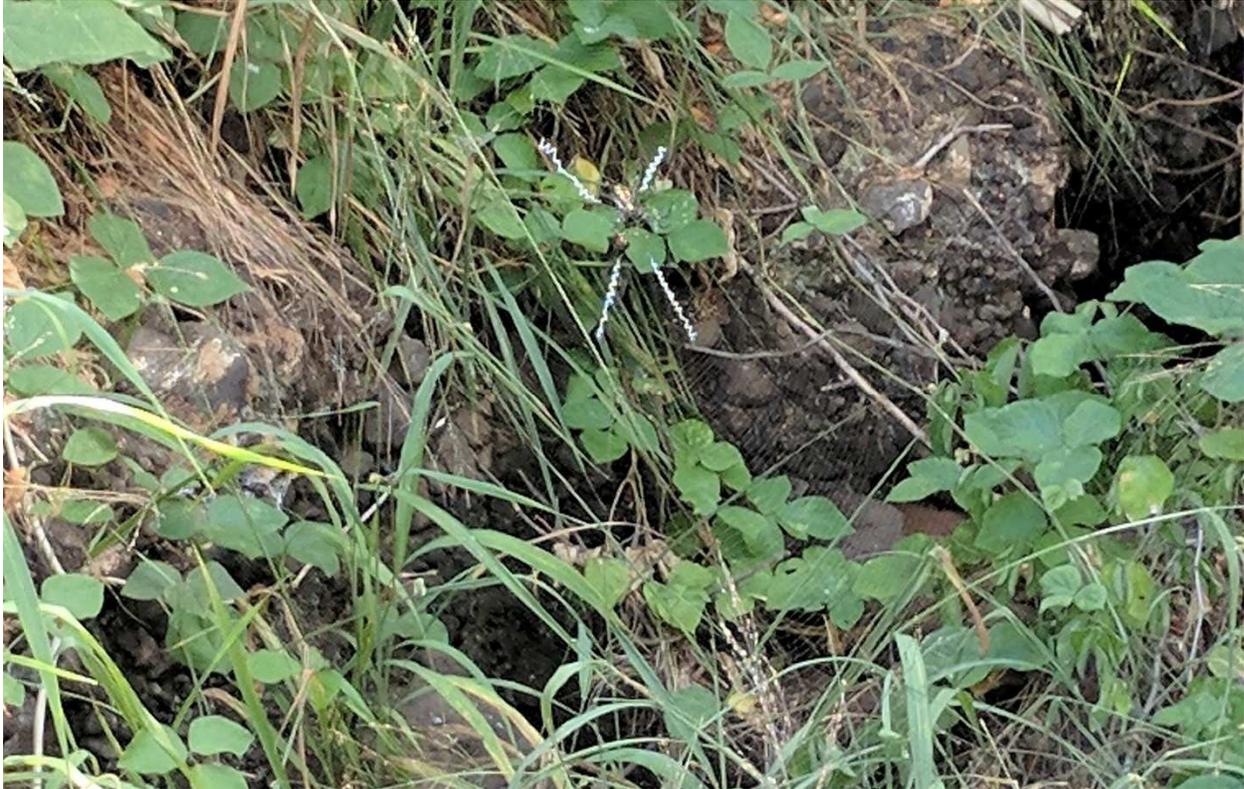
Photo 6: Signs of erosion at the invert of the drainageway near the bottom of the project area

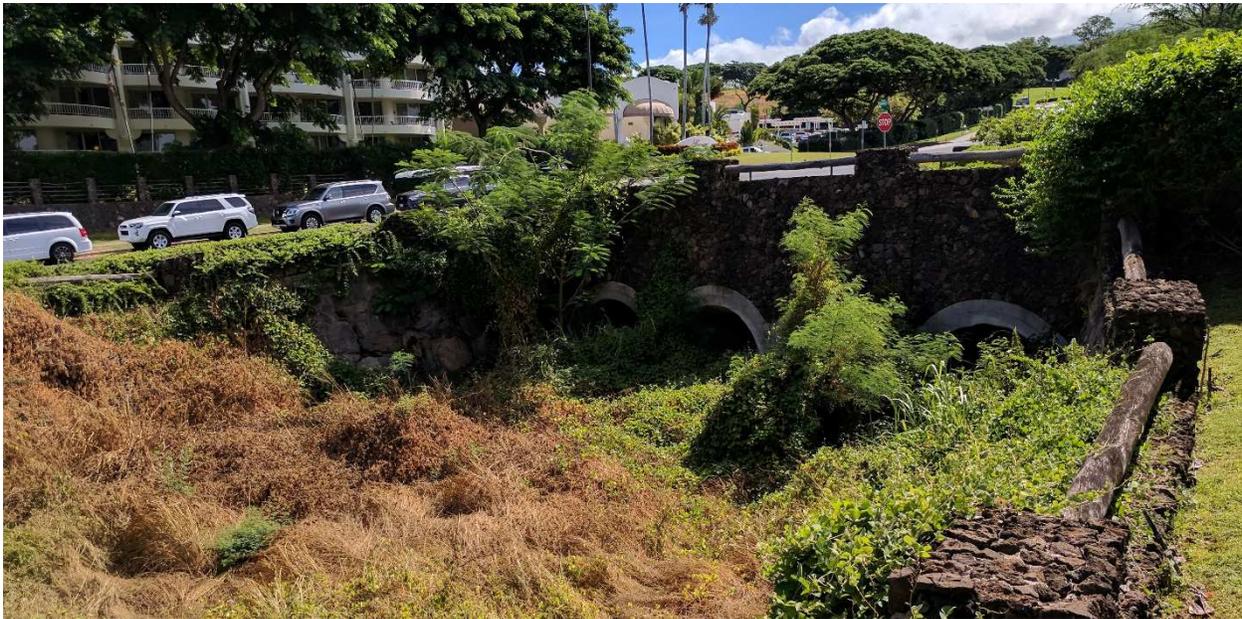
Photo 7: Looking upstream toward the four 90” drain lines crossing under Ualei Place
