FINAL PALAUEA CULTURAL RESERVE

Palauea, Kīhei, Maui, Hawai'i
Tax Map Key: (2) 2-1-023:034

DRAINAGE INSPECTION REPORT

October 30, 2017

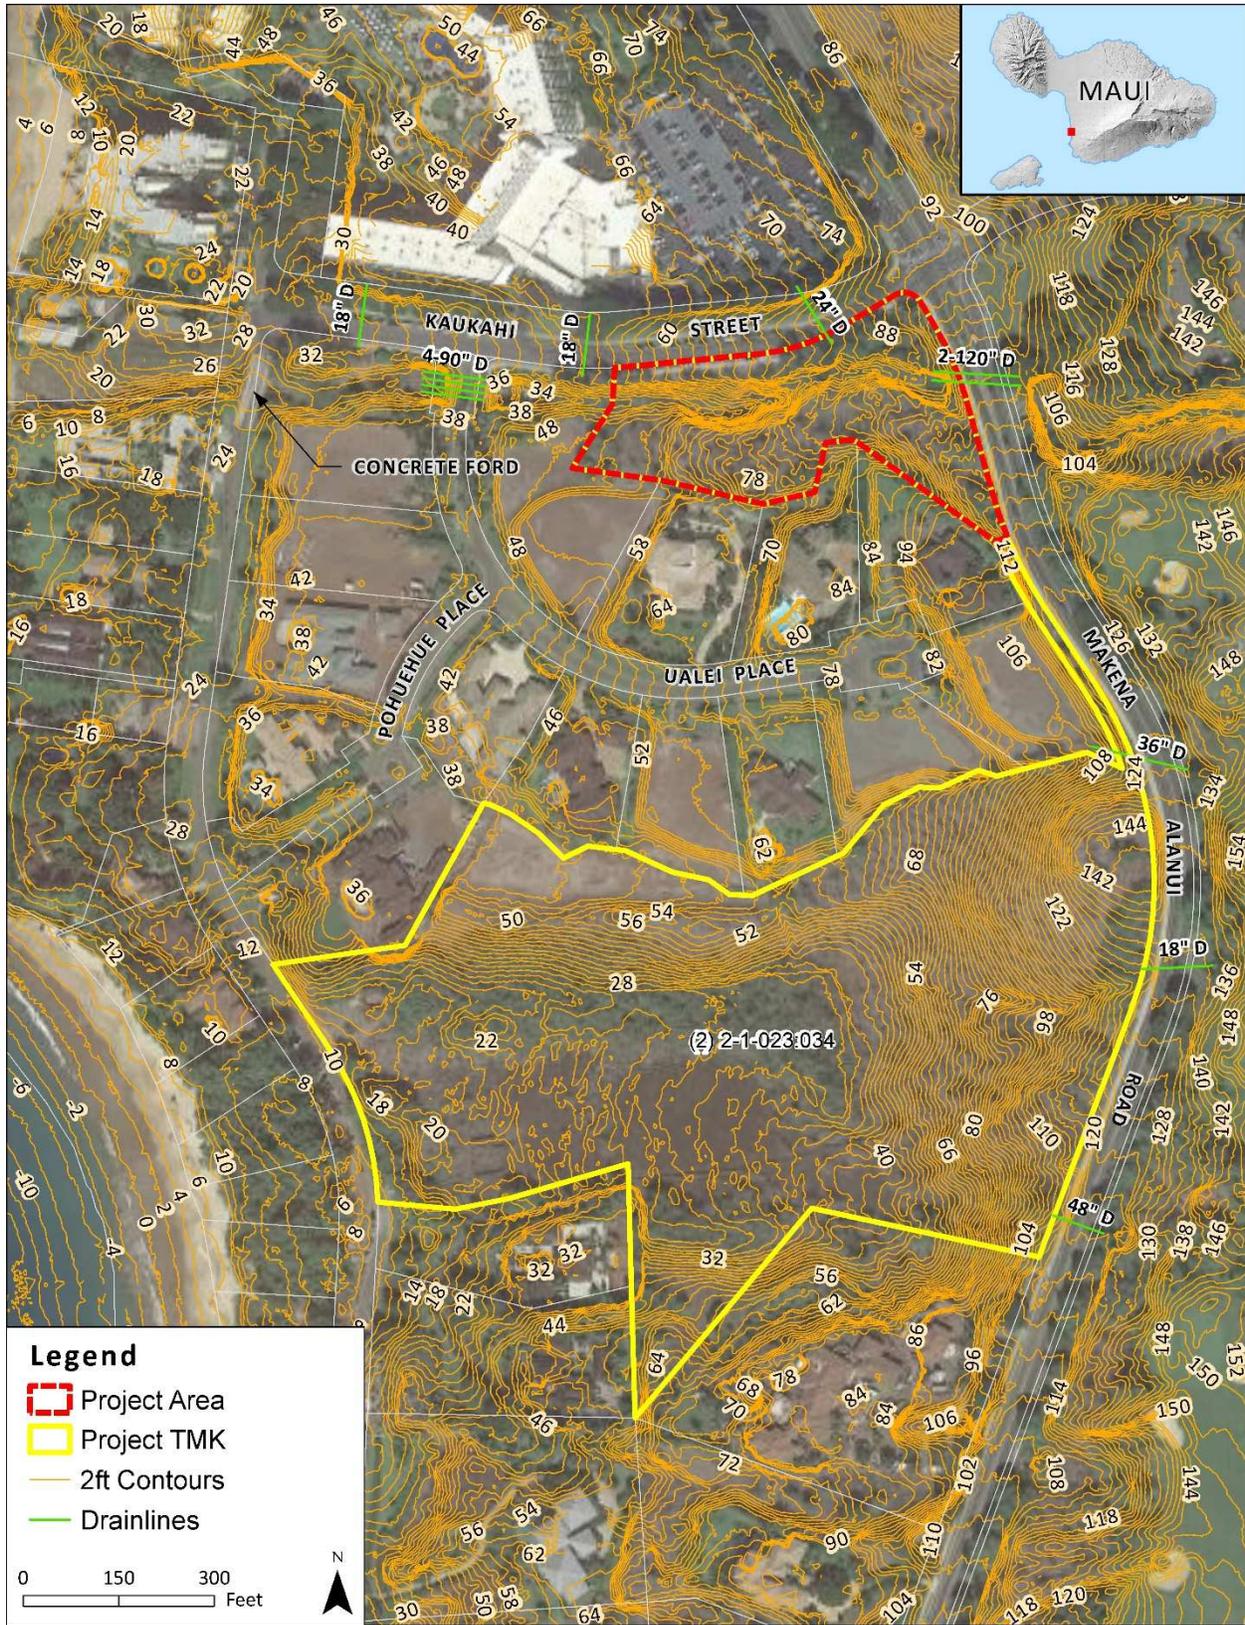
Figure 2: Existing Topography and Drain Culvert Locations

According to the ATA report, there are three (3) drainage culverts that discharge runoff into the drainage channel along Kaukahi Street including a 24-inch culvert and two (2) 18-inch culverts as shown on Figure 2. Along the drainage channel there are three roadway crossings with culverts and a concrete ford. There are two (2) 120-inch culverts at the Makena Alanui Drive crossing, four (4) 90-inch culverts at the Ualei Place crossing, and a concrete ford at Makena Road as shown on Photo 1 and Figure 2. A red painted bollard with signage provides warning to motorists and pedestrians not to cross the ford if runoff is flowing across the road.

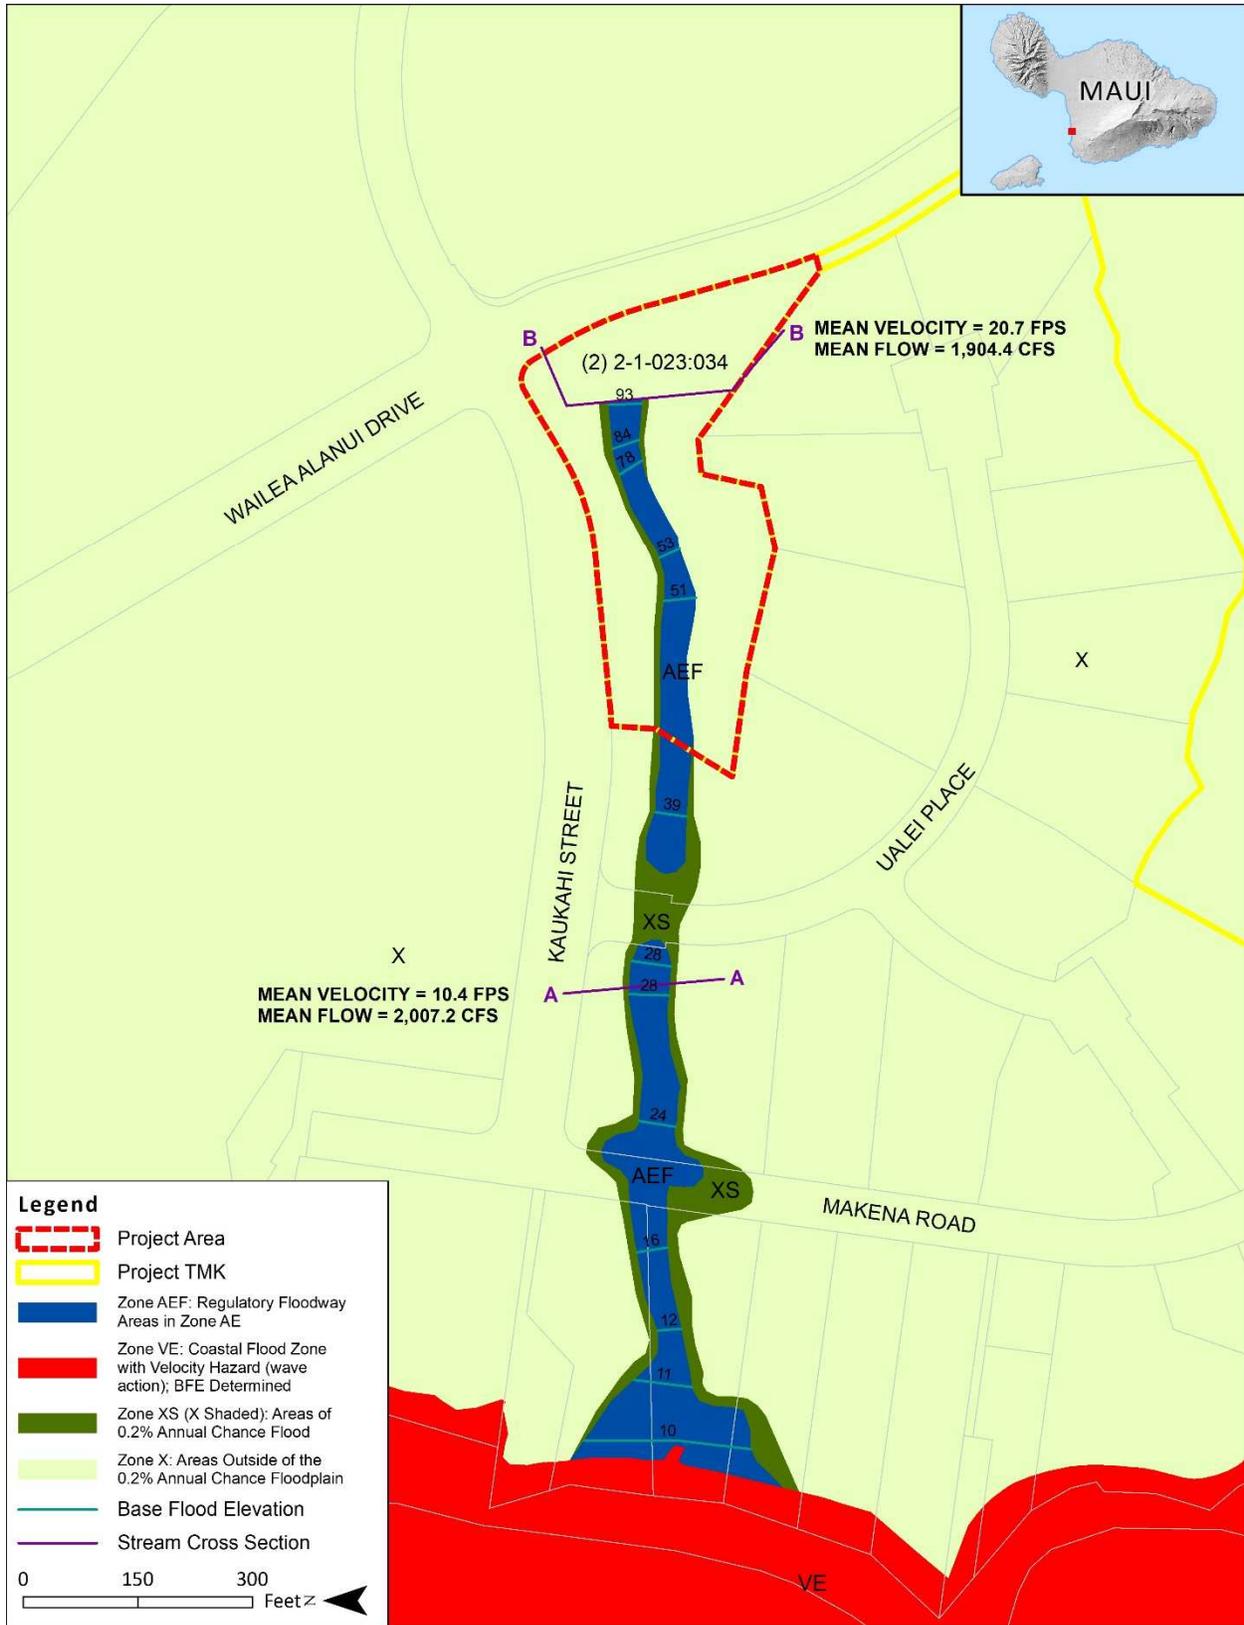
According to the Flood Insurance Rate Map, Panel Number 1500030678F, dated November 4, 2015, the project area is located in Flood Zones XS and AEF. Flood Zone XS means the area has a 0.2% annual chance of flooding, which is a low-to-moderate risk flood zone. Flood Zone AEF means the area is a floodway and is subject to inundation by the 1-percent-annual chance flood event. Figure 3 identifies the project area and the limits for each flood zone. Floodway data including peak flow rates, flow velocities, and the channel profile for Kihei Gulch 4 is excerpted from the FIS and is attached to this report and also depicted on Figure 3.

The FIS identifies two (2) cross sections in Kihei Gulch 4. One is located at the top of the project area just below Makena Alanui Road (Section B-B), and the second section is located just downstream of the four 90-inch culverts that cross Ualei Place (Section A-A). The study identifies Section B-B of the channel to have a 33-foot wide channel bottom with a 100-year rainfall event mean flow of 1,904.4 cubic feet per second (cfs) and a mean velocity of 20.7 feet per second (fps). This is consistent with the Otomo report. At Section A-A, the channel widens to an 88-foot wide channel bottom with a 100-year rainfall event mean flow of 2,007.2 cfs and a mean velocity of 10.4 fps. Based on the base flood elevations, the 100-year storm appears to be contained within the channel with an average depth of 2 to 3 feet.

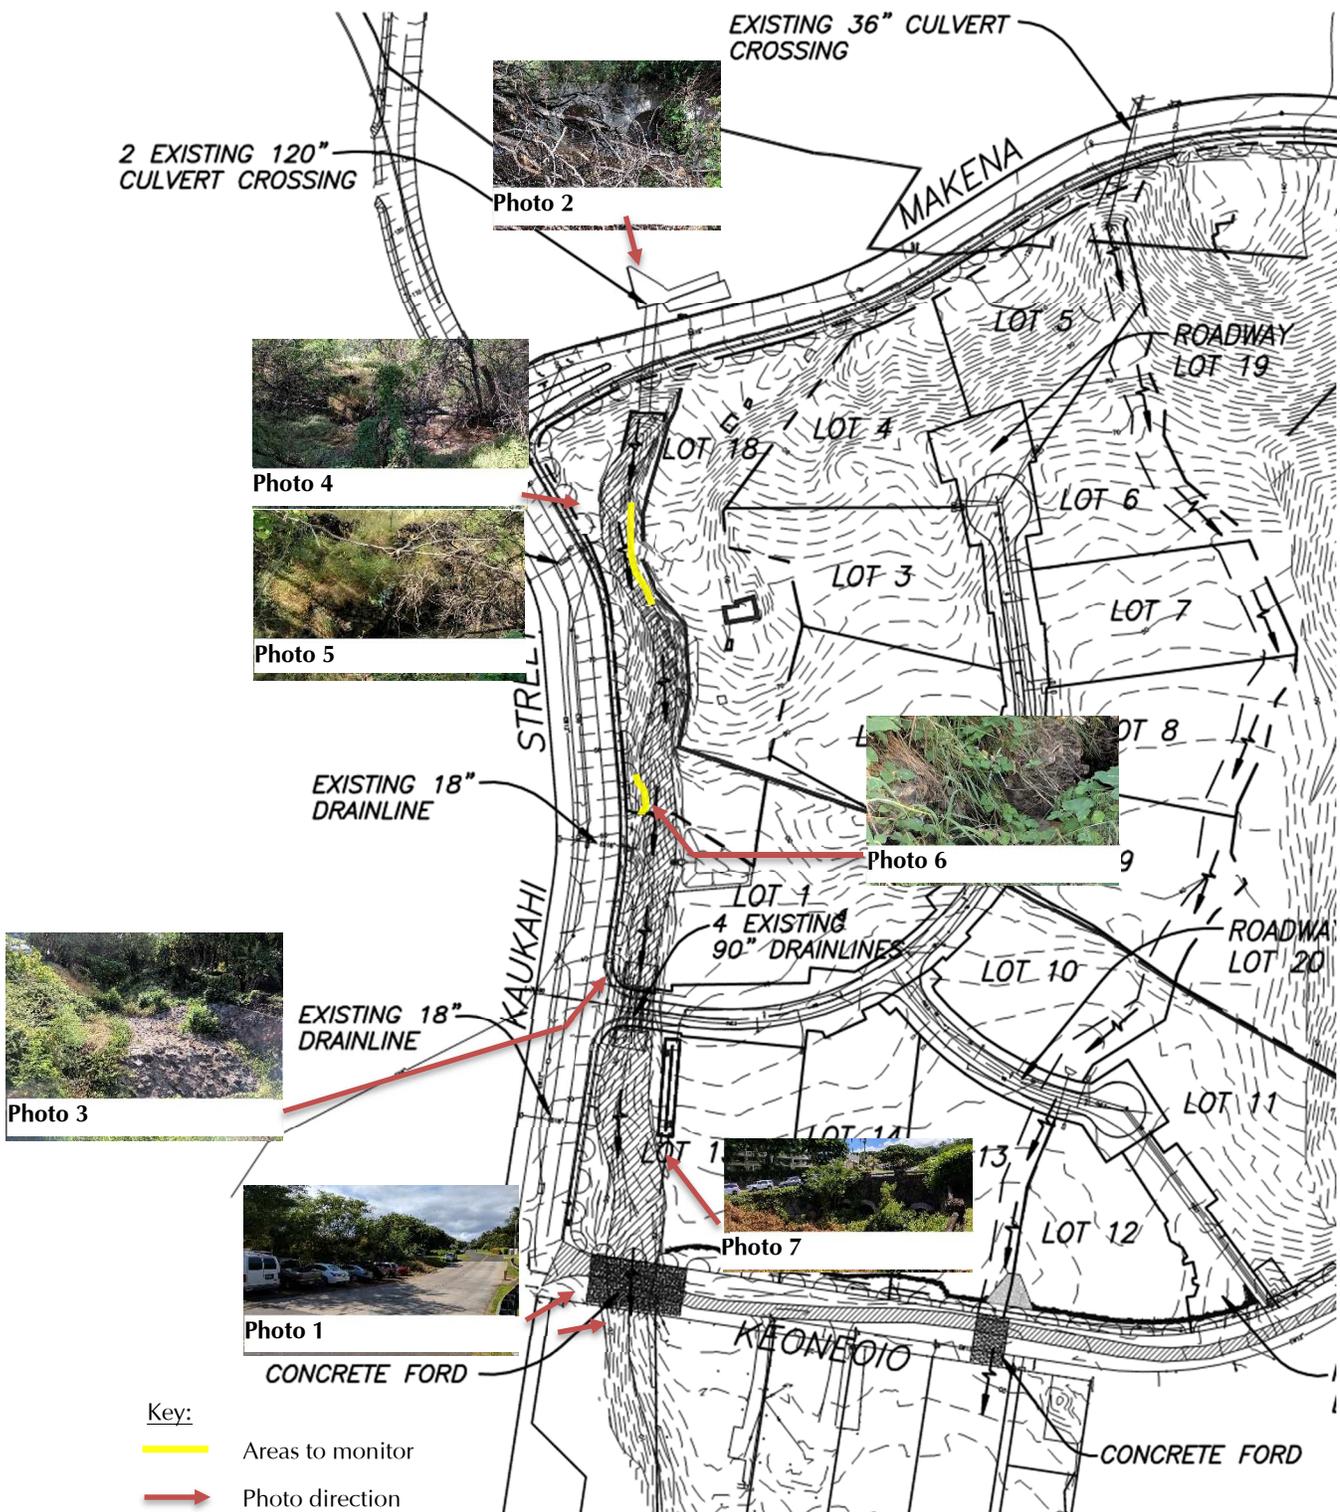
Based on the drainage inspection conducted on August 22, 2017, the drainage channel doesn't appear to require immediate maintenance. However, we recommend clearing the vegetation (e.g. cut grass to 4" to 9" height and remove clippings; remove dead vegetation, dead trees, loose debris, etc.) to conduct a follow up inspection to verify the location and condition of the existing drain outlets along Kaukahi Street and reinspection of the drainageway to identify additional areas of concern. When clearing, do not grub or destroy vegetation and roots holding soil and channel together. Doing so may compromise the integrity of the channel. Figure 5 highlights the area to be cleared for further inspection.

- Remove all large loose objects that may impede the natural flow of storm runoff (e.g. boulders, abandoned refuse, etc.).
- Remove any dead vegetation, dead trees, and other vegetative debris.
- Remove or prune any trees and plants that could create hazardous conditions or impede conveyance of storm water runoff (e.g. large trees in the middle of the channel, tree that may fall over, etc.).
- Restore vegetative cover and fix any eroded areas.
- Visually inspect eroded slopes. Action should be taken if the conditions worsen.
